1997-2003 BMW 5 Series DVD drive mechanism in BMW MKIV navigation computer Replacement

If your BMW MKIV navigation computer stops reading discs you can replace the dvd drive mechanism with a simple set of tools and the replacement part from www.bimmernav.com/url/mkivfix

Written By: Martin Bishop

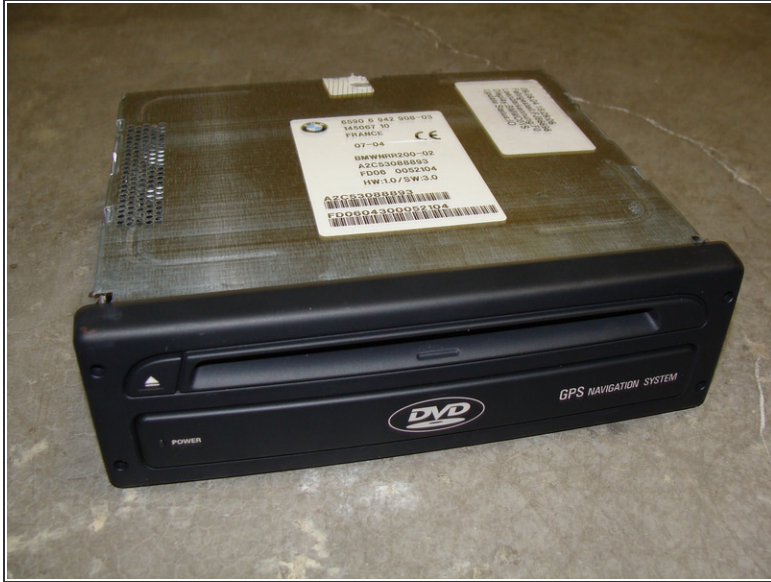
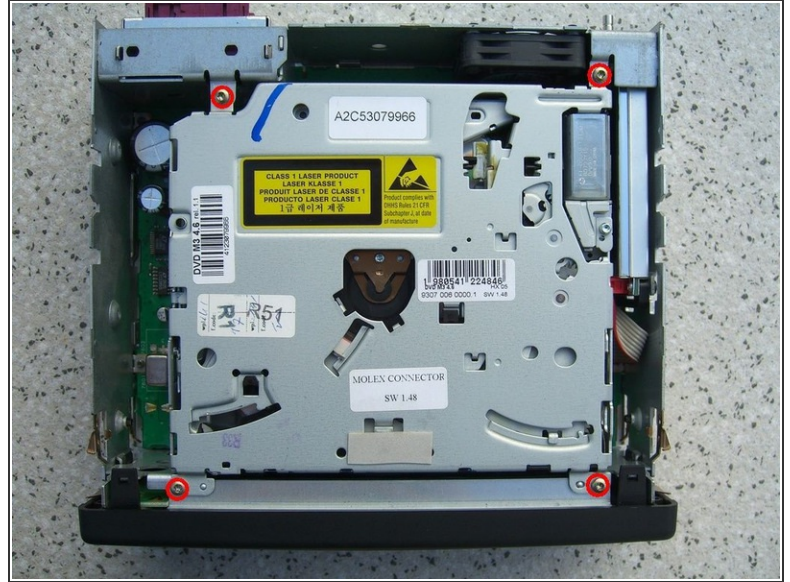
Step 1 — Replacing DVD drive mechanism in BMW MKIV navigation computer

- To replace the DVD mechanism in the BMW MKIV Navigation drive, you will need to start with getting the replacement internal part. We recommend www.bimmernav.com
- On the back of the MKIV are a series of stickers. Any stickers that connect between the top lid and the sides or back need to be removed or cut to allow the top lid to be removed
- Remove the top lid by lifting up by your fingers. The lid is made of very thin metal and it is best to work slowly around the lid with your fingers to avoid bending the lid
- Once the lid is removed using the torx 8 driver remove each of the 4 screws carefully trying not to drop or loose these small screws. Screw heads are marked in photos

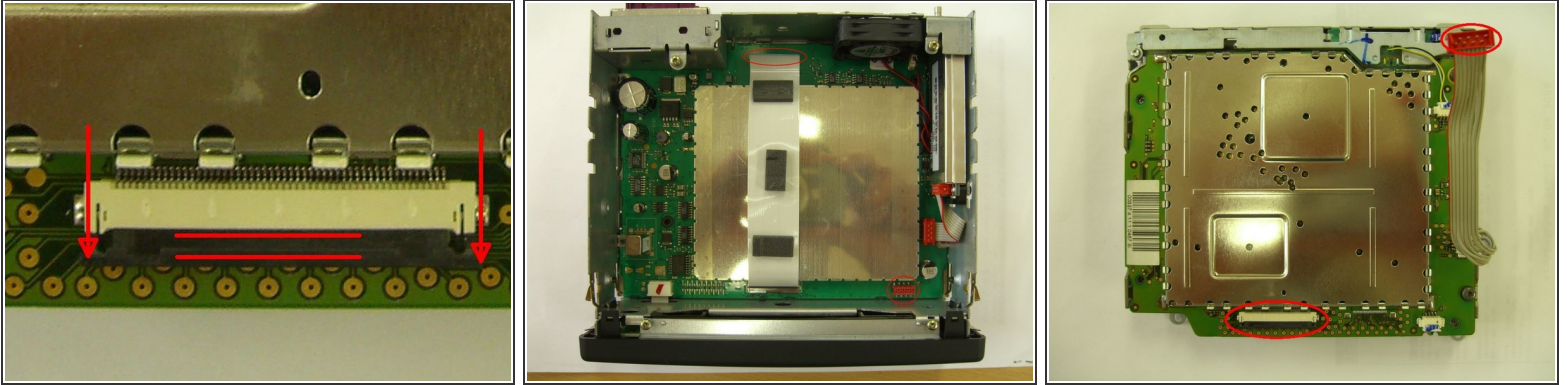
Step 2

- Once the Screws are removed gently lift the dvd mechanism out of the way to reveal the connectors.
- The Ribbon cable is secured into place with a locking lever. To release it you first have to move the locking mechanism on both sides carefully with a small screwdriver towards the cable as shown in photo. TAKE NOTE of which end connects to each side as the ribbon cable MUST be reconnected the same direction
- To remove the power plug gently pull straight up on the power plug to release it from unit. When replacing the DVD mechanism you will be reusing the power plug and ribbon cable.
- Replacing the new drive is a simply reverse of this process

To reassemble your device, follow these instructions in reverse order.
